FZK-263-1  
20 OCTOBER 1965

**NERVA MATERIALS  
IRRADIATION PROGRAM**  
Volume 1  
**GTR Test 16 — AGC Materials Test**

Prepared for  
Space Nuclear Propulsion Office  
of the  
National Aeronautics and Space Administration  
Cleveland, Ohio

**NUCLEAR AEROSPACE RESEARCH FACILITY**

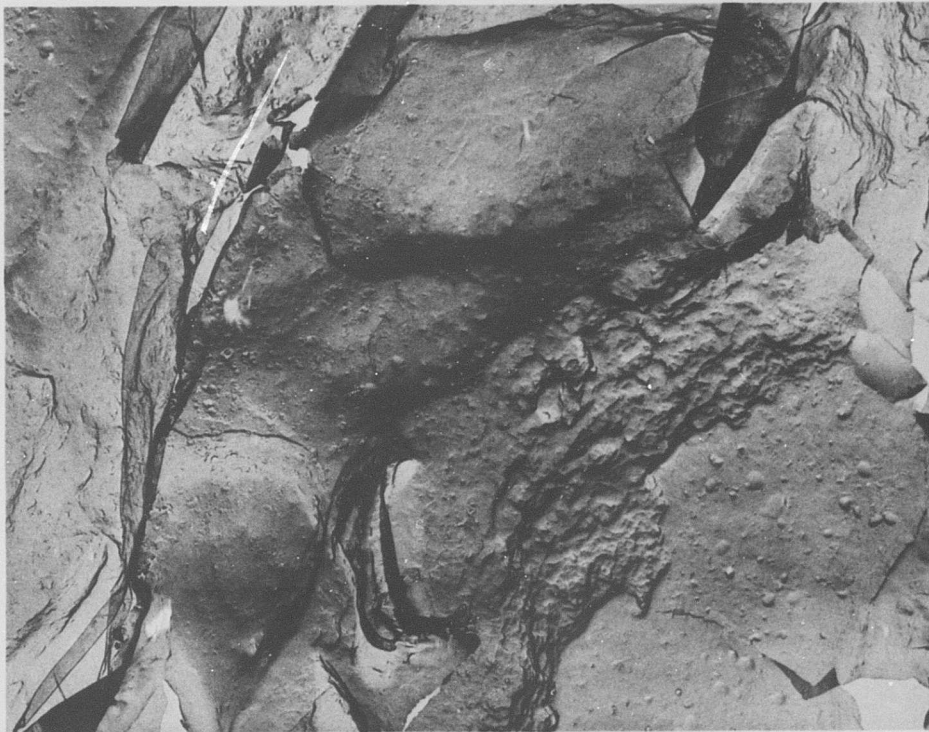
Material Aluminum 7075-T6 Neg.No. 97-6  
Specimen LN 113 Neg.Mag. 2,100X  
Etchant None Photo Enlargement 2X

This fractograph of the notched specimen shows small microvoid regions and some intergranular fracture.

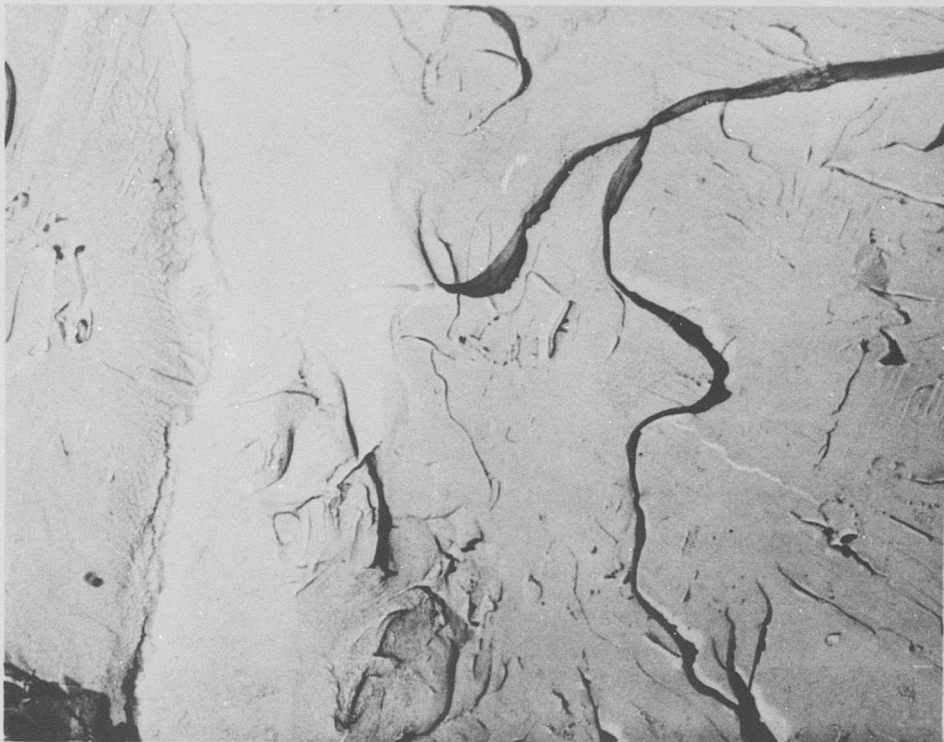
Material Stainless Steel 347C Neg.No. 93-10  
Specimen LU 178 Neg.Mag. 2,100X  
Etchant None Photo Enlargement 2X

The fracture surface of this area at the center of the specimen is made up of large quasi-cleavage facets and what appear to be grain-boundary fractures between the facets. The area in the middle of the photograph shows evidence of the failure of the high Cr-Fe phase. The area on the right represents the fracture of one large austenitic grain, quite possibly through or adjacent to the bands in Figure C-105 running through the austenite grain.

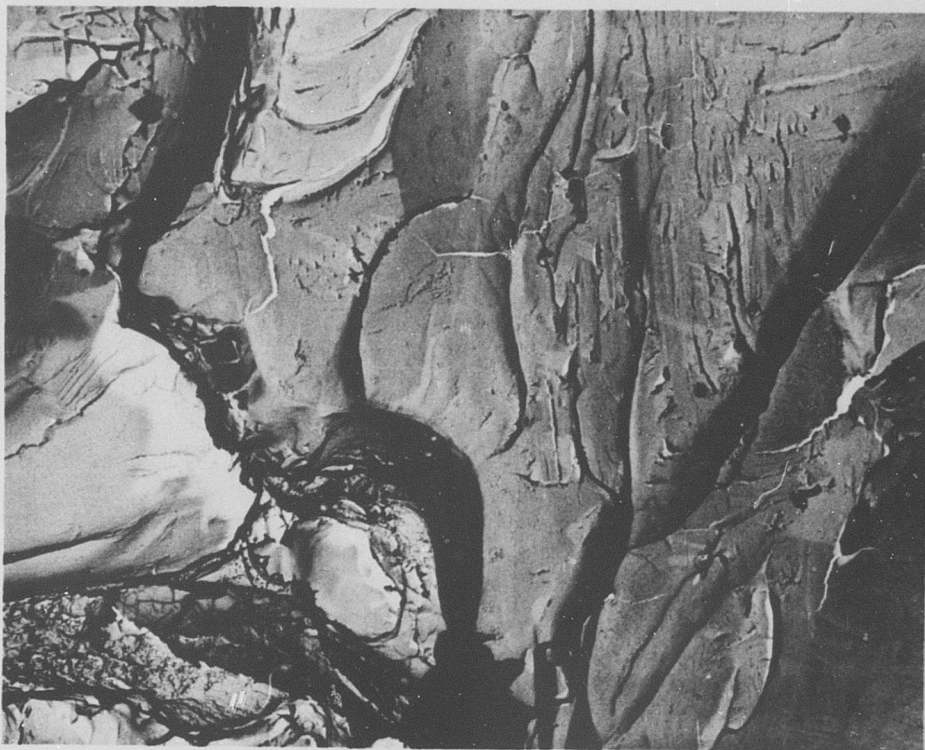
Material	<u>Stainless Steel 347C</u>	Neg.No.	<u>93-2</u>
Specimen	<u>LU 178</u>	Neg.Mag.	<u>2,100X</u>
Etchant	<u>None</u>	Photo Enlargement	<u>2X</u>

The fracture surface at the edge of the specimen exhibited the same characteristics as at the center: large quasi-cleavage facets, some intergranular fracture at the austenite/ferrite interface, and isolated areas of microvoid fracture.

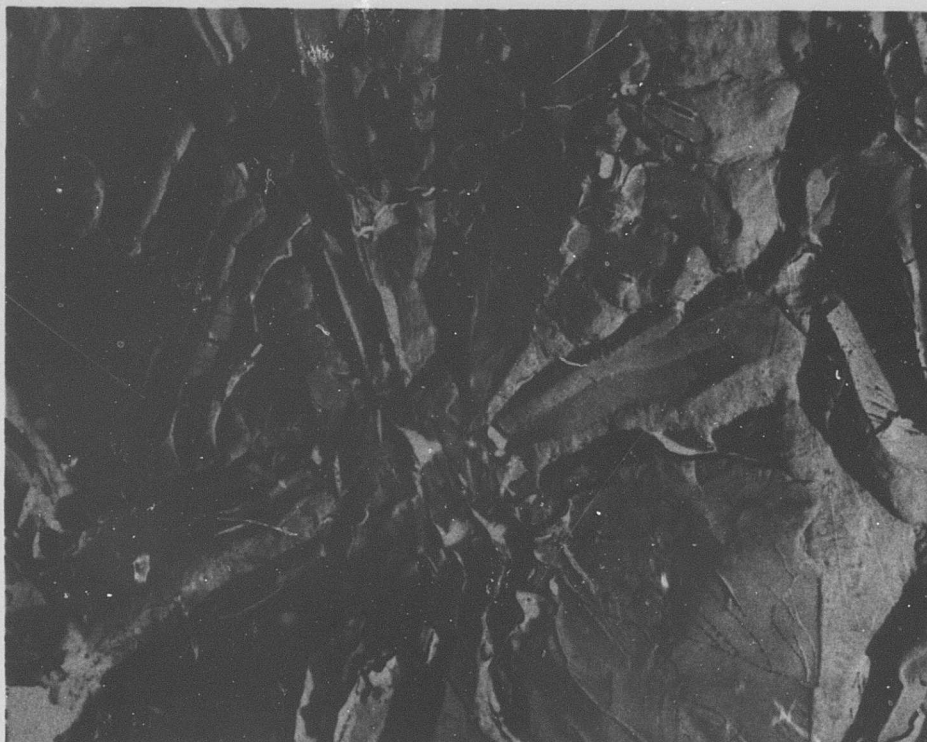
Material Stainless Steel 347C Neg.No. 100-5  
Specimen LN 185 Neg.Mag. 2,100X  
Etchant None Photo Enlargement 2X

The fracture is a reflection of the cast structure.  
The individual facets are a very brittle cleavage  
type.

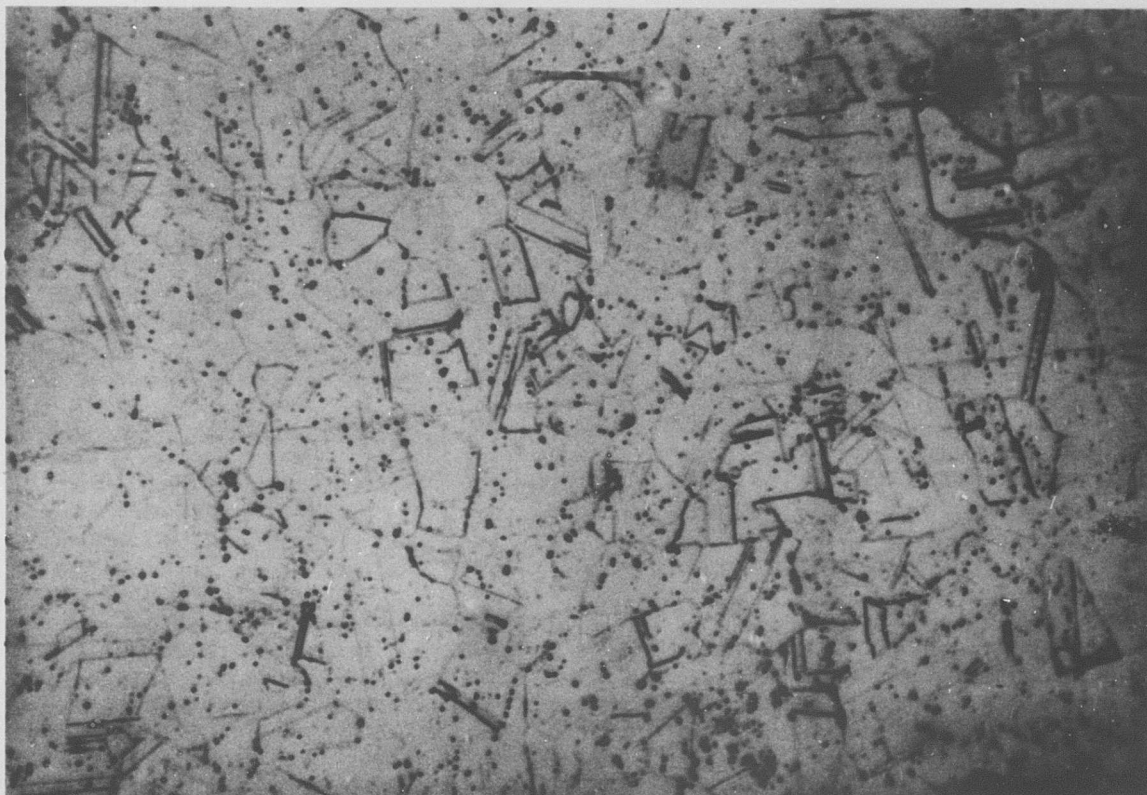
Material Stainless Steel 347 Neg.No. W10  
Specimen LU 702 Neg.Mag. 1,000X  
Etchant 10% Amonium Persulfate Photo Enlargement None

The austenitic microstructure shows the original annealing twins and carbide dispersion. There appears to be some carbide (and grain boundary) sensitization.

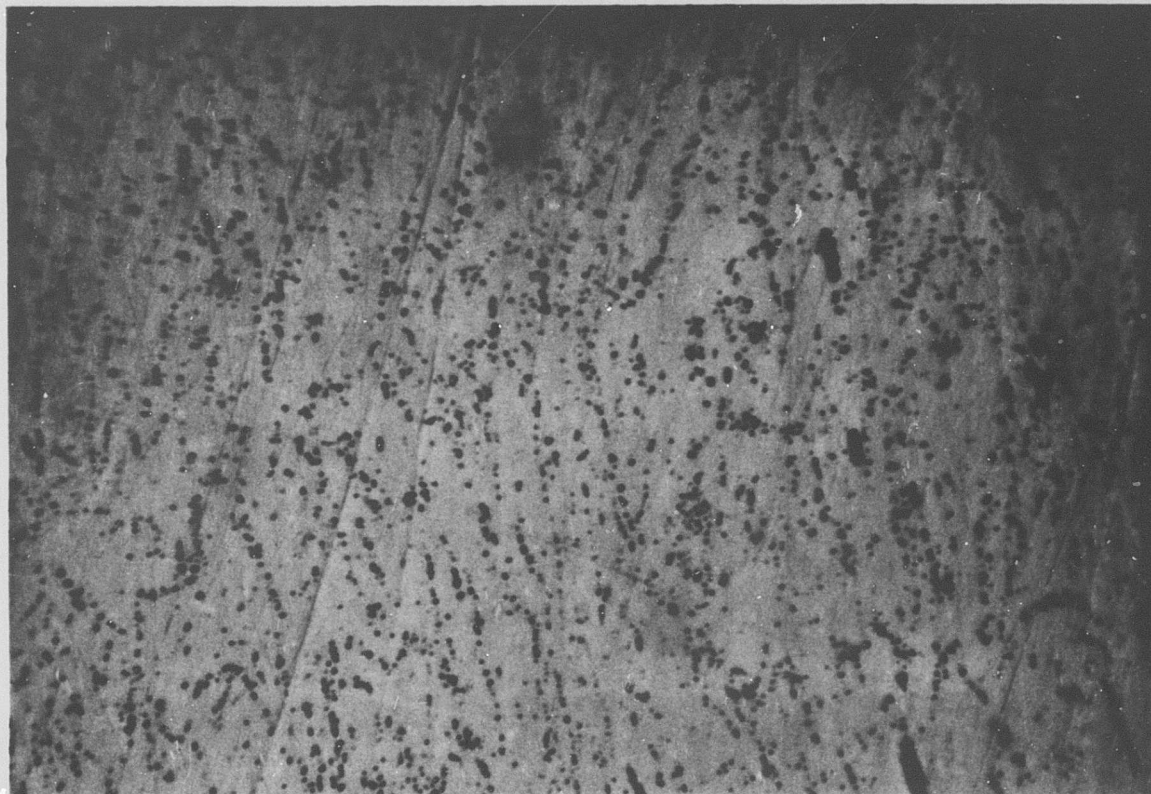
Material Stainless Steel 347 Neg.No. W80  
Specimen LU 702 Neg.Mag. 1,000X  
Etchant 10% Amonium Persulfate Photo Enlargement None

The austenitic microstructure shows carbide dispersion through the matrix.

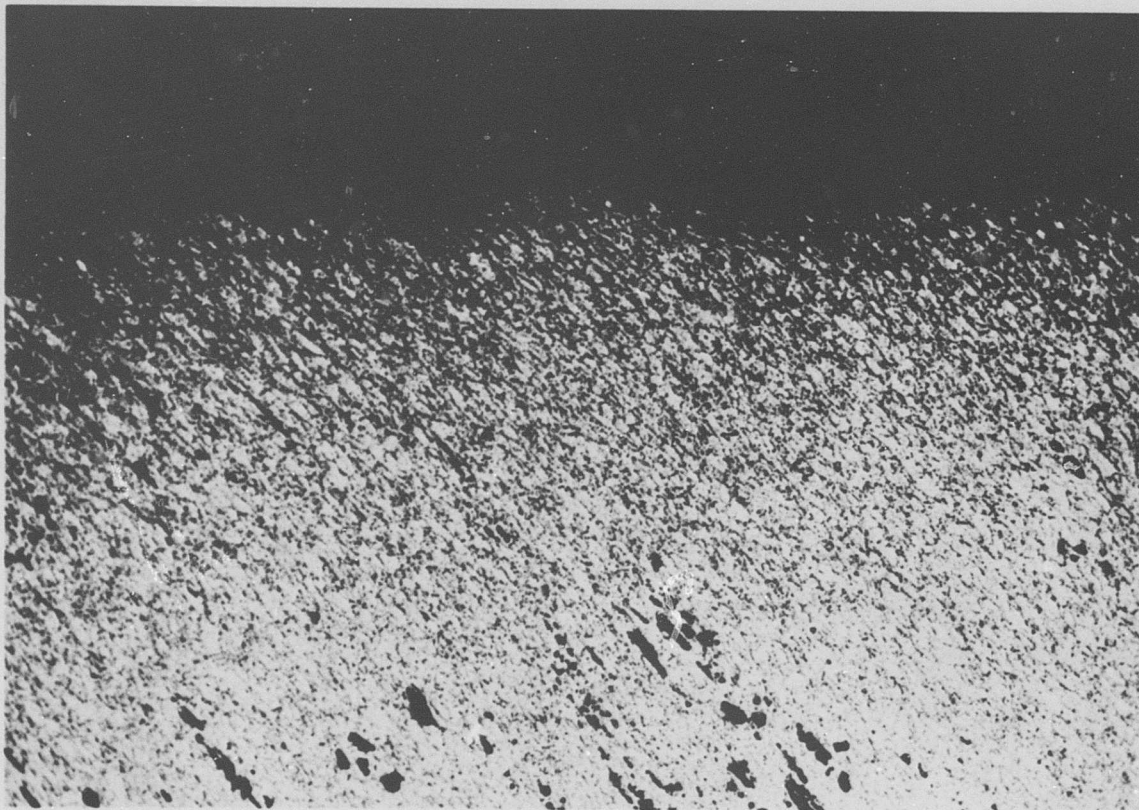
Material Stainless Steel 347 Neg.No. W69  
Specimen LU 702 Neg.Mag. 100X  
Etchant 10% Amonium Persulfate Photo Enlargement None

The optical micrograph of the fracture edge shows the austenitic microstructure with large areas of nonmetallic inclusions.

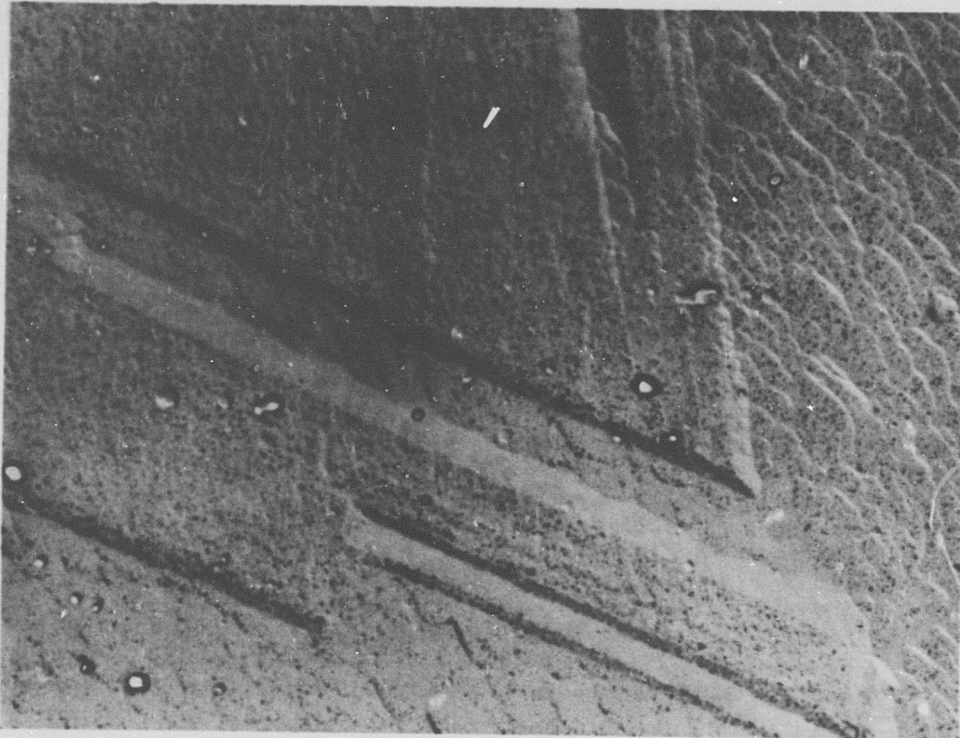
Material Stainless Steel 347 Neg.No. 103-1  
Specimen LU 702 Neg.Mag. 7,500X  
Etchant 10% Amonium Persulfate Photo Enlargement 2X

The structure shows annealing twins in austenite and fine carbide dispersion. The texture reveals grain orientation.

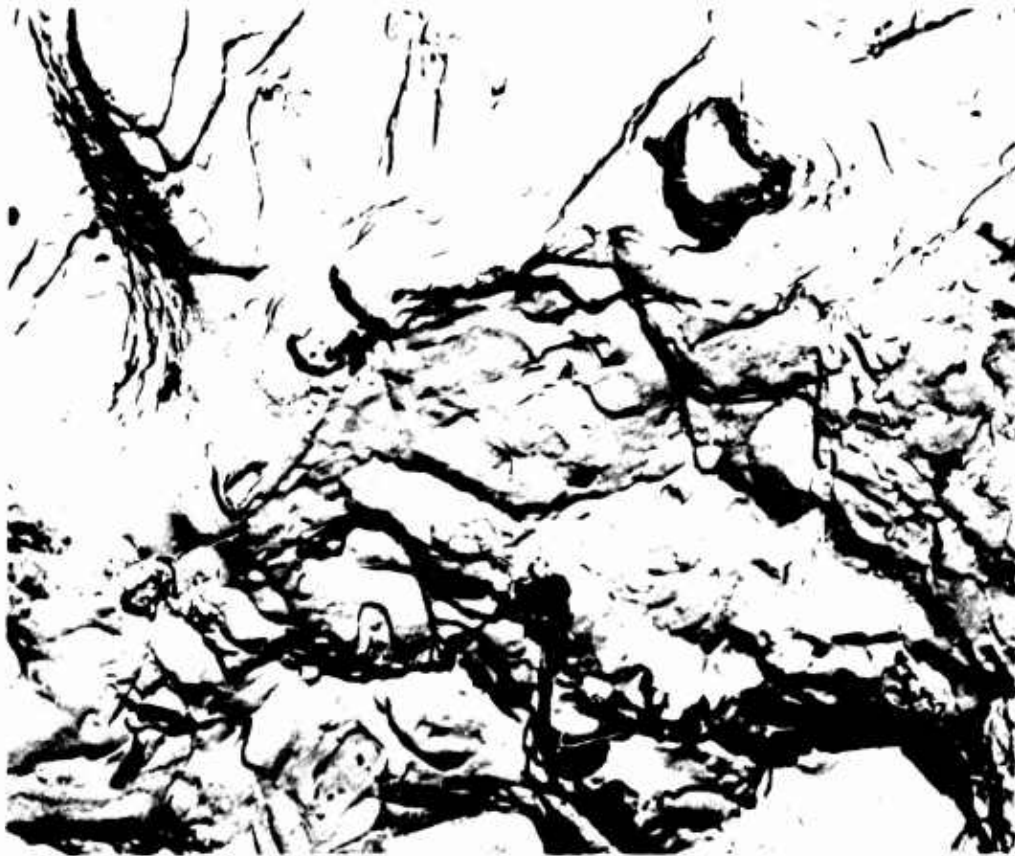
Material Stainless Steel 347 Neg.No. 93-6  
Specimen LWU 204 Neg.Mag. 2,100X  
Etchant None Photo Enlargement 2X

The fracture at the center is made up of microvoid and intergranular fractures. The intergranular facet in the center of the photograph shows a brittle ferrite particle that failed and was removed during replication. The smaller round particles present on the fracture represent carbides.

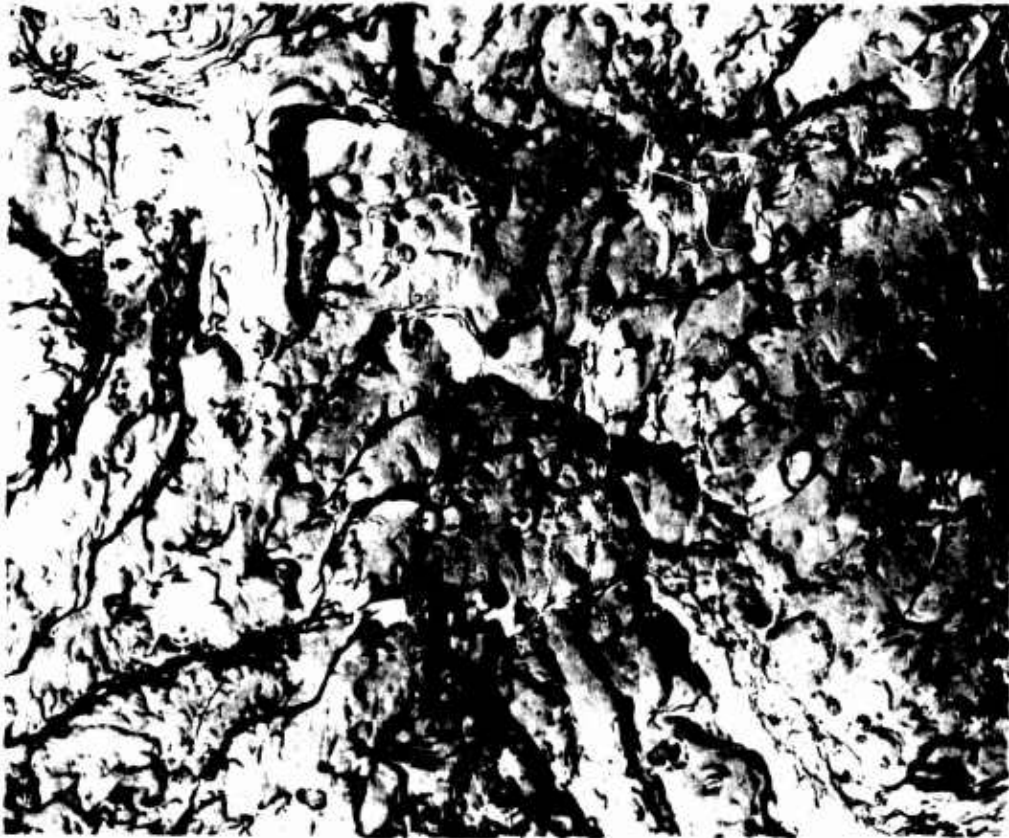
Material Stainless Steel 347 Neg.No. 98-5  
Specimen LWN 210 Neg.Mag. 2,100X  
Etchant None Photo Enlargement 2X

The fracture is composed mainly of quasi-cleavage facets; however, some small dimples are present. There are indications of plastic flow at the edges of the cleavage facets, indicating a semi-brittle rather than completely brittle failure mode.

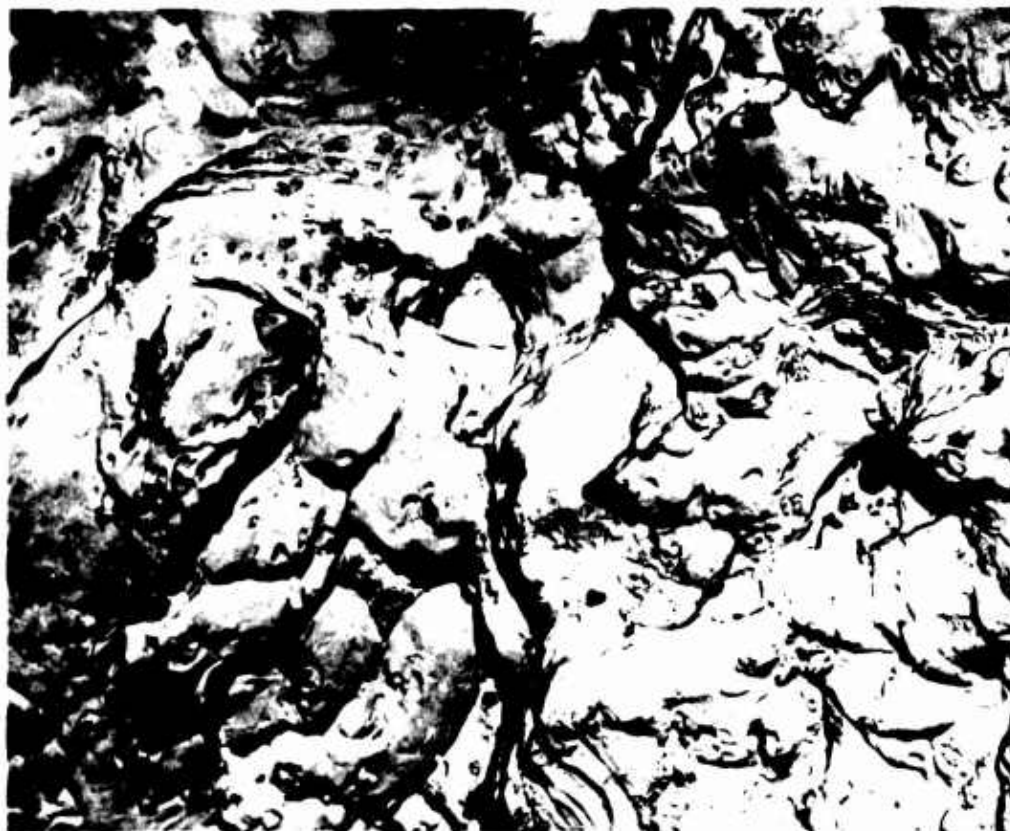
Material Stainless Steel 347 Neg.No. 98-4  
Specimen LWN 210 Neg.Mag. 2,100X  
Etchant None Photo Enlargement 2X

The fracture is composed mainly of large dimples, indicating that the fracture was ductile in this local area. Near the upper right-hand corner is an area that indicates localized segregation during welding and the fracture follows the cast structure produced. The pitted appearance that is present in isolated areas is oxidation.

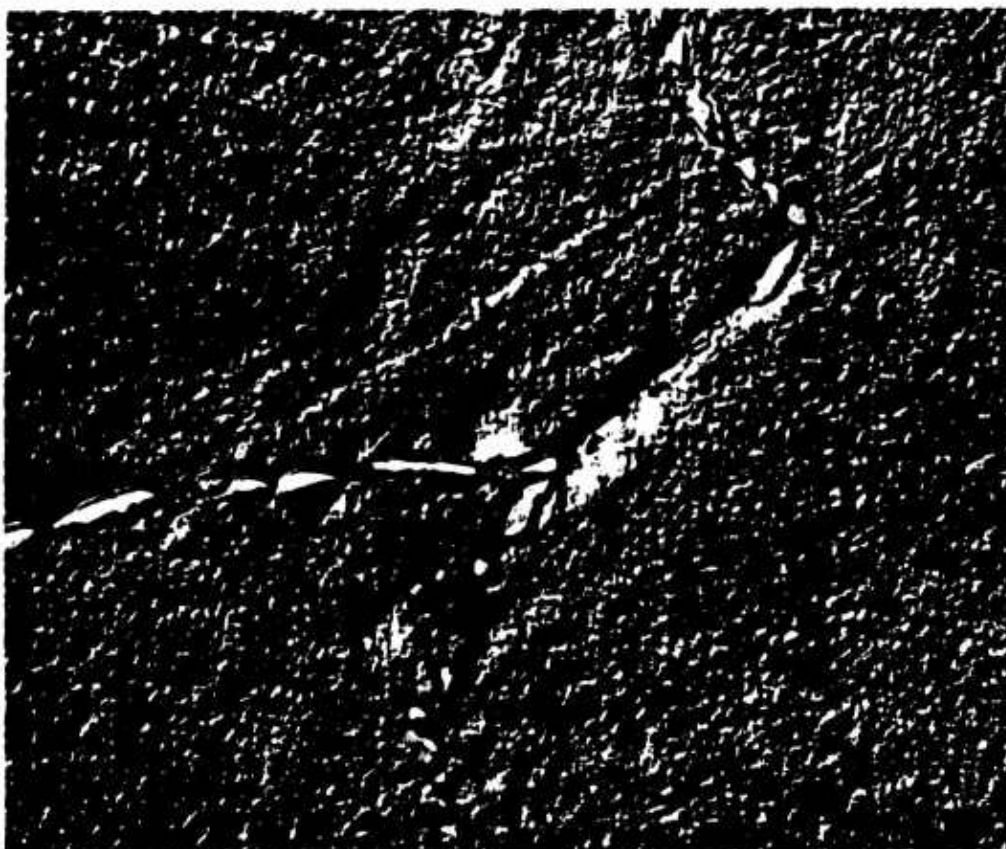
Figure C-151 Stainless Steel A-286, Condition L: Electron Micrograph Showing 15,000X Magnification of Strained Area

Material Stainless Steel A-286 Neg.No. 106-8  
Specimen LU 214 Neg.Mag. 7,500X  
Etchant 10% Oxalic Acid (electrolytic) Photo Enlargement 2X

The microstructure shows an austenite-matrix grain boundary and a precipitate along the boundary.  
Faint strain lines are visible.

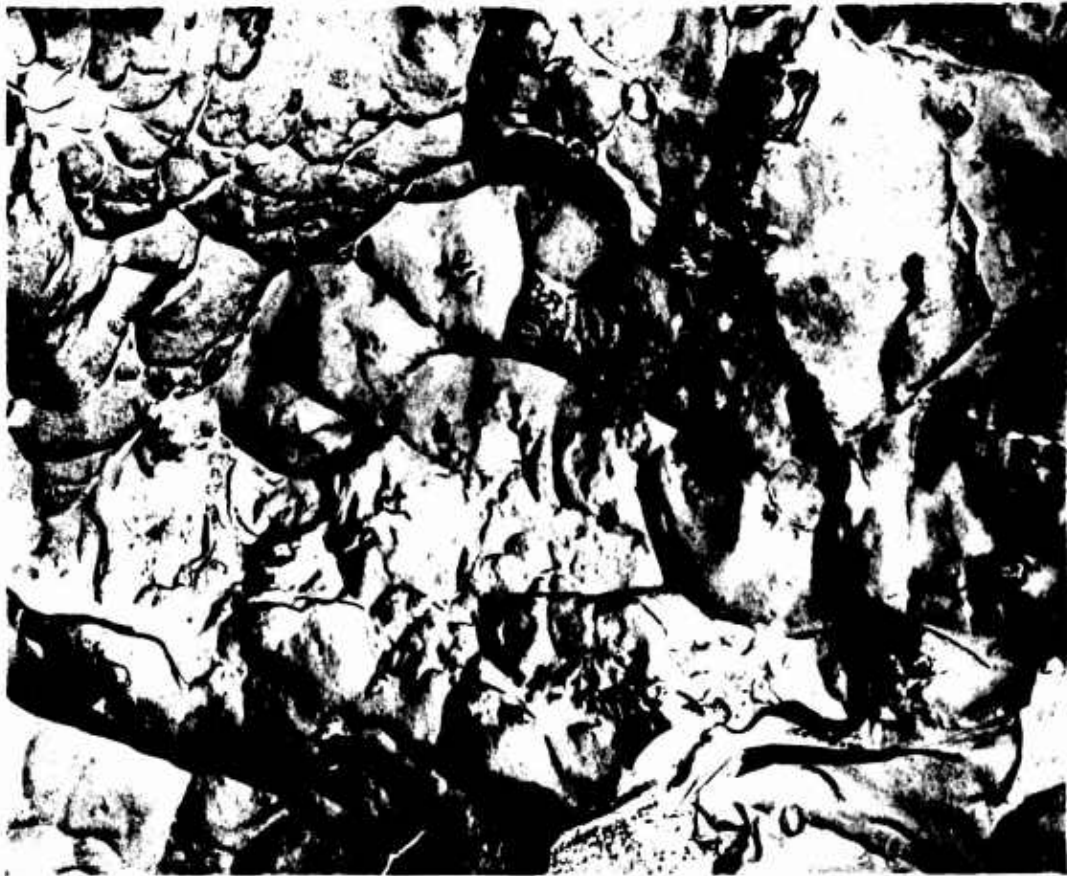
Figure C-152 Stainless Steel A-286, Condition L: Electron Fractograph Showing 4,200X Magnification at Center of Fracture

Material Stainless Steel A-286 Neg.No. 111-5  
Specimen LU 214 Neg.Mag. 2,100X  
Etchant None Photo Enlargement 2X

The fractograph of the center area shows a microvoid fracture mode, which is indicative of a ductile failure. Both small and large equiaxed dimples are present.

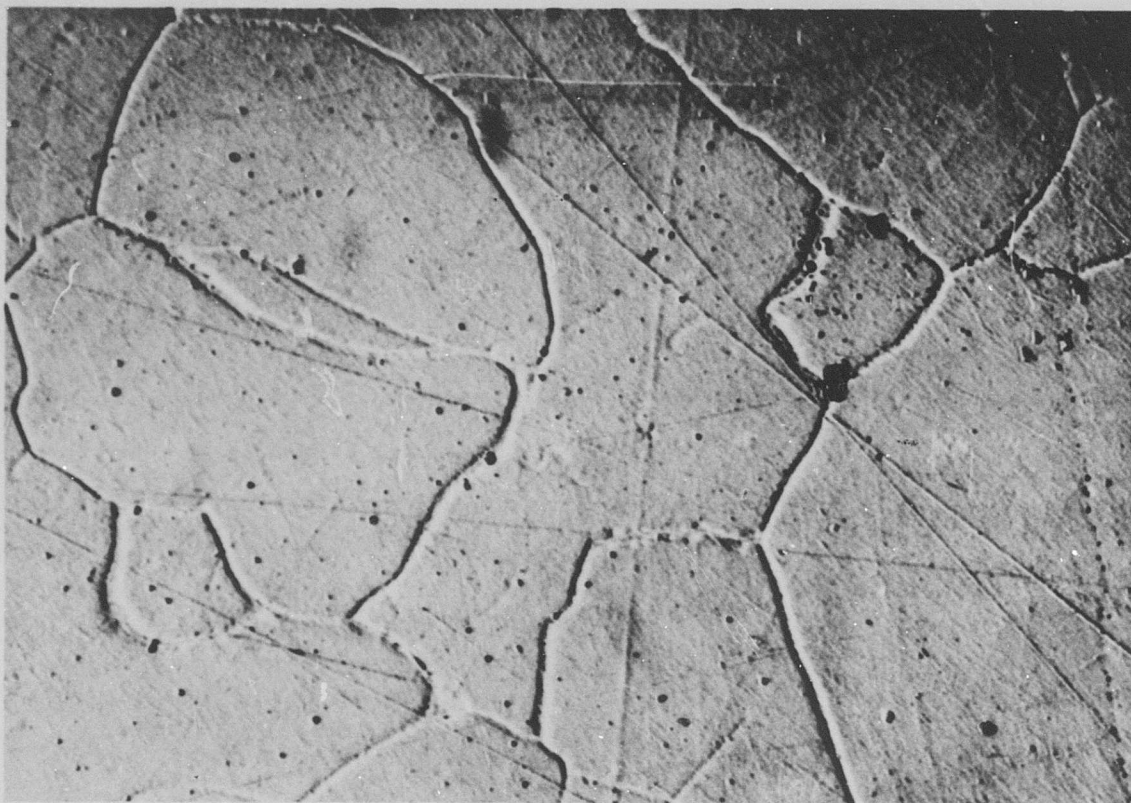
Figure C-160 Inconel X-750, Condition L: Optical Micrograph Showing 1,000X Magnification of Unstrained Area

Material Inconel X-750 Neg.No. W81  
Specimen LU 382 Neg.Mag. 1,000X  
Etchant 10% Oxalic Acid (electrolytic) Photo Enlargement None

The microstructure shows an austenitic matrix with fine, dispersed carbides and a continuous precipitate at the grain boundaries.

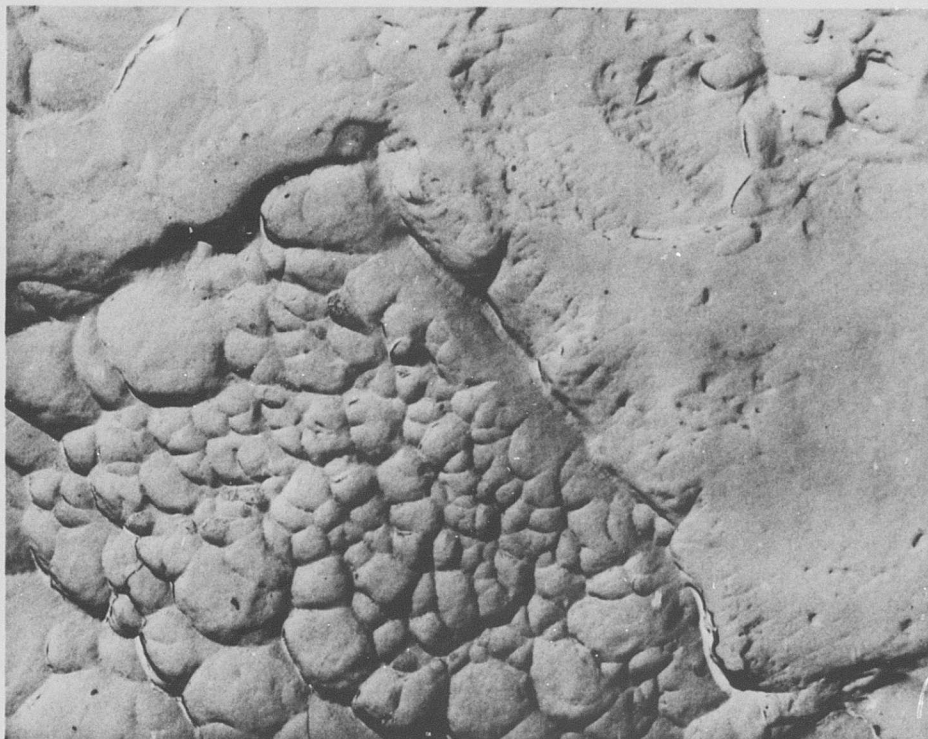
Figure C-167 Inconel X-750, Condition L: Electron Fractograph Showing 4,200X Magnification at Center of Fracture

Material Inconel X-750 Neg.No. 96-12  
Specimen LU 382 Neg.Mag. 2,100X  
Etchant None Photo Enlargement 2X

The fracture at the central area of the specimen is made up of oriented dimples and glide-plane decohesion. The boundary in the center of the photograph is, in all probability, a grain boundary. In the grain on the right, a glide or slip plane is lined up with the shearing stresses and the failure is by glide-plane decohesion. In the area on the left, the plane of easy glide is not lined up and the failure is by microvoid formation and link-up. This type of fracture is associated with ductile failure.

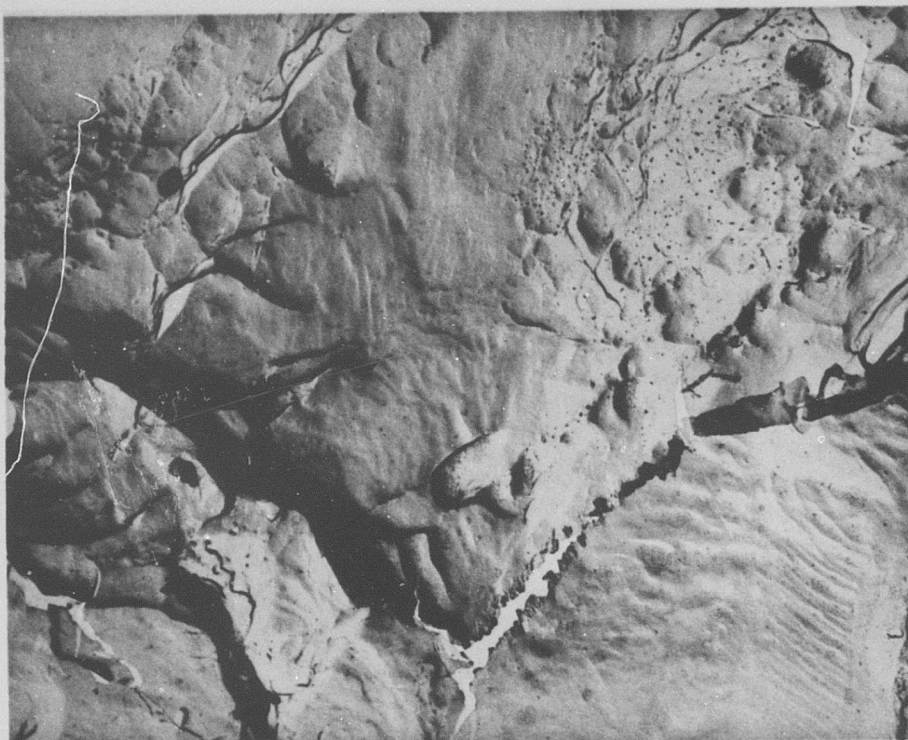
Figure C-169b Inconel X-750, Condition L: Electron Fractograph Showing 4,200X Magnification of Notched Fracture

Material Inconel X-750 Neg.No. 97-11  
Specimen LN 389 Neg.Mag. 2,100X  
Etchant None Photo Enlargement 2X

This area of the fracture surface is composed of dimples and serpentine glide.

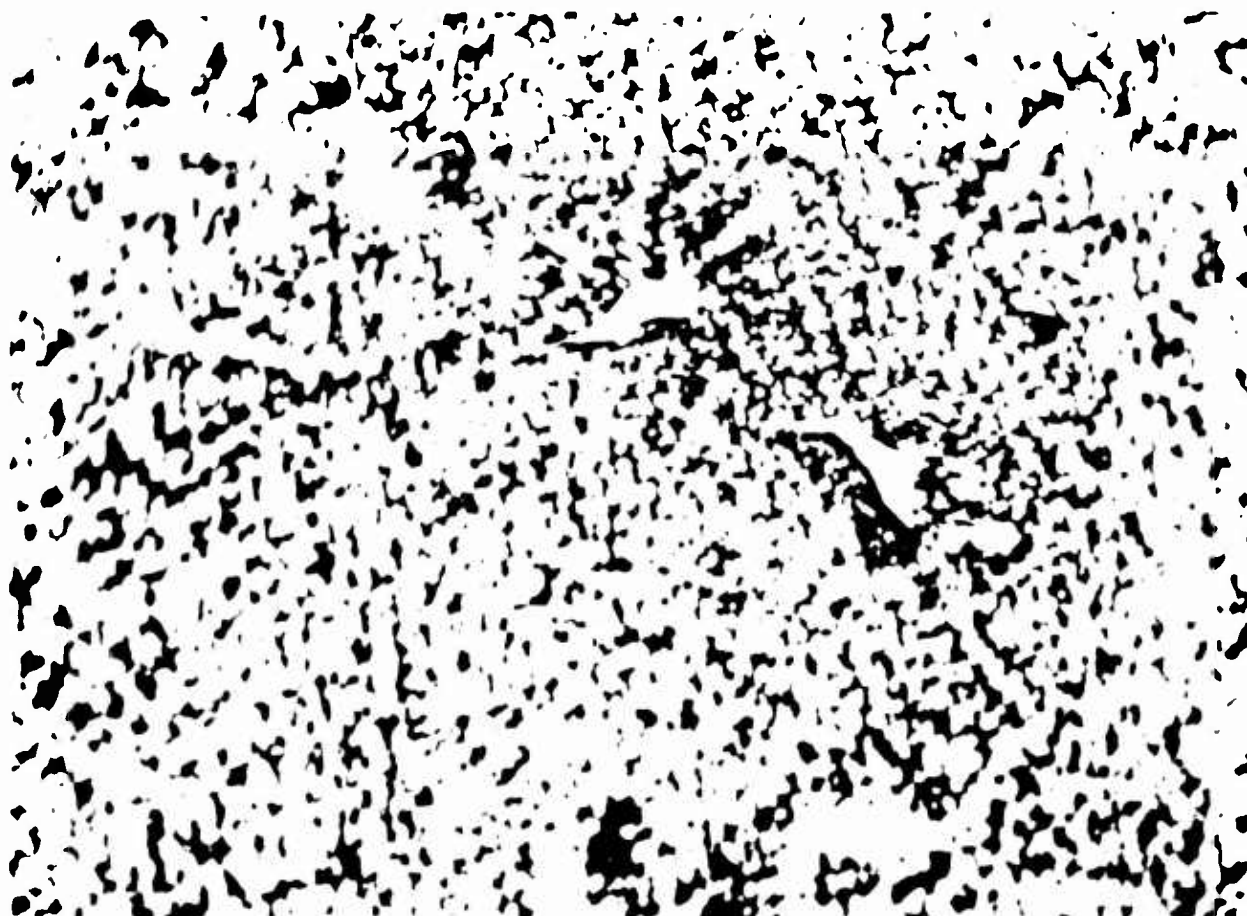
Figure C-175 Inconel 713C, Condition L: Optical Micrograph Showing 1,000X Magnification of General Strained Area

Material Inconel 713C Neg.No. W13  
Specimen LU 401 Neg.Mag. 1,000X  
Etchant 10% Oxalic Acid (electrolytic) Photo Enlargement None

The microstructure shows the Ni-Cr phase that constitutes the grain matrix. Gamma prime precipitate is the primary strengthening mechanism. The grain boundary network contains Ti-C.

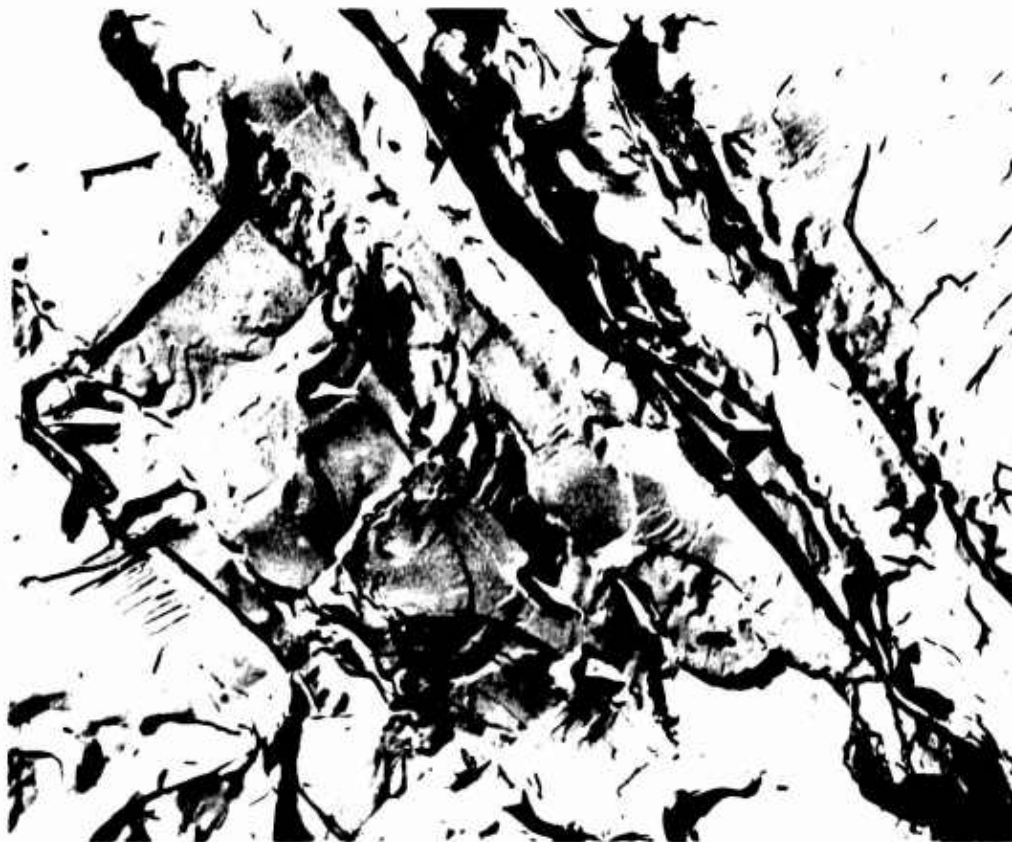
Material	<u>Inconel 713C</u>	Neg.No.	<u>96-6</u>
Specimen	<u>LU 401</u>	Neg.Mag.	<u>2,100X</u>
Etchant	<u>None</u>	Photo Enlargement	<u>2X</u>

The fracture topography at the edge was the same as that found at the center (Fig. C-180).

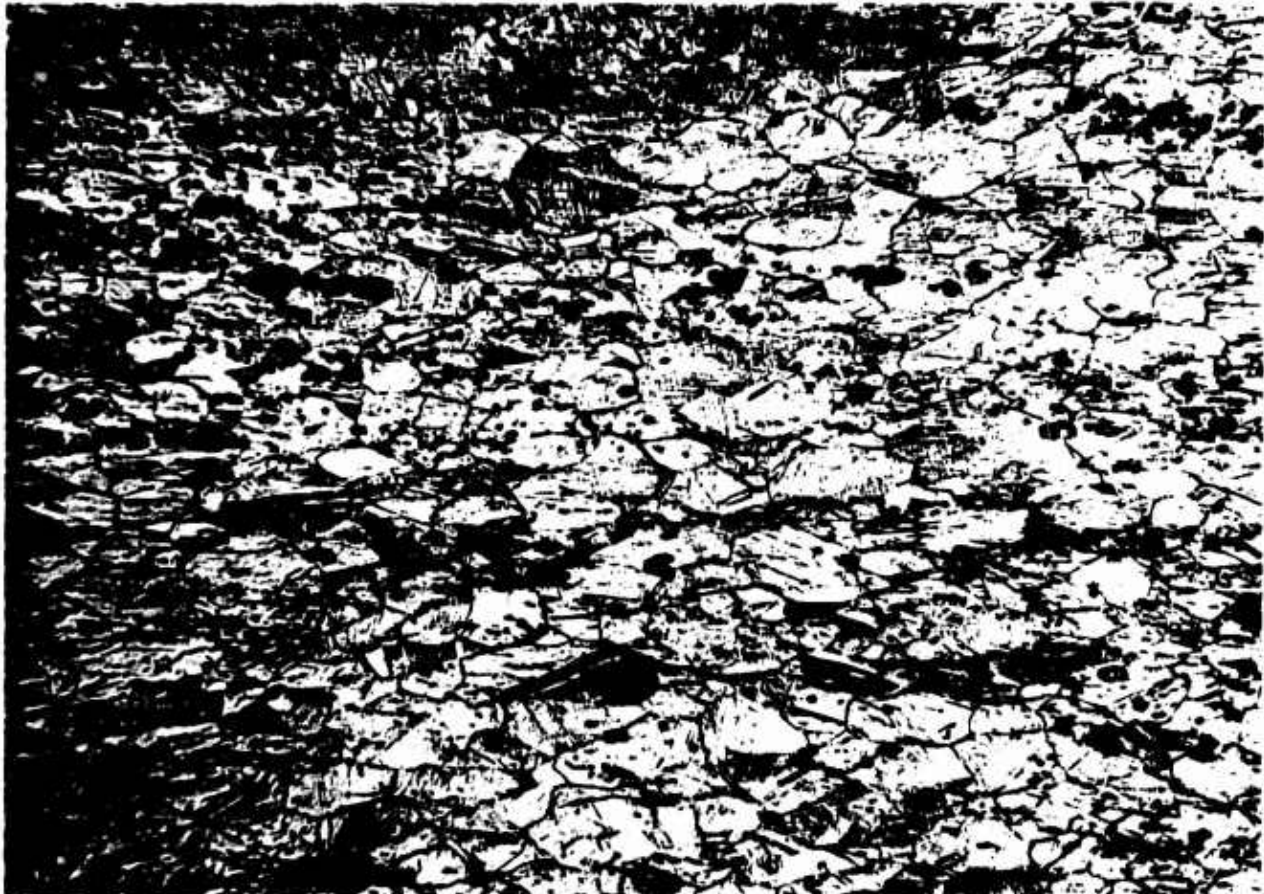
Material Hastelloy C Neg.No. W73  
Specimen LU 354 Neg.Mag. 100X  
Etchant HCl+H<sub>2</sub>O<sub>2</sub> Photo Enlargement None

The microstructure of the strained area shows a severely deformed, Ni-rich, austenitic matrix.

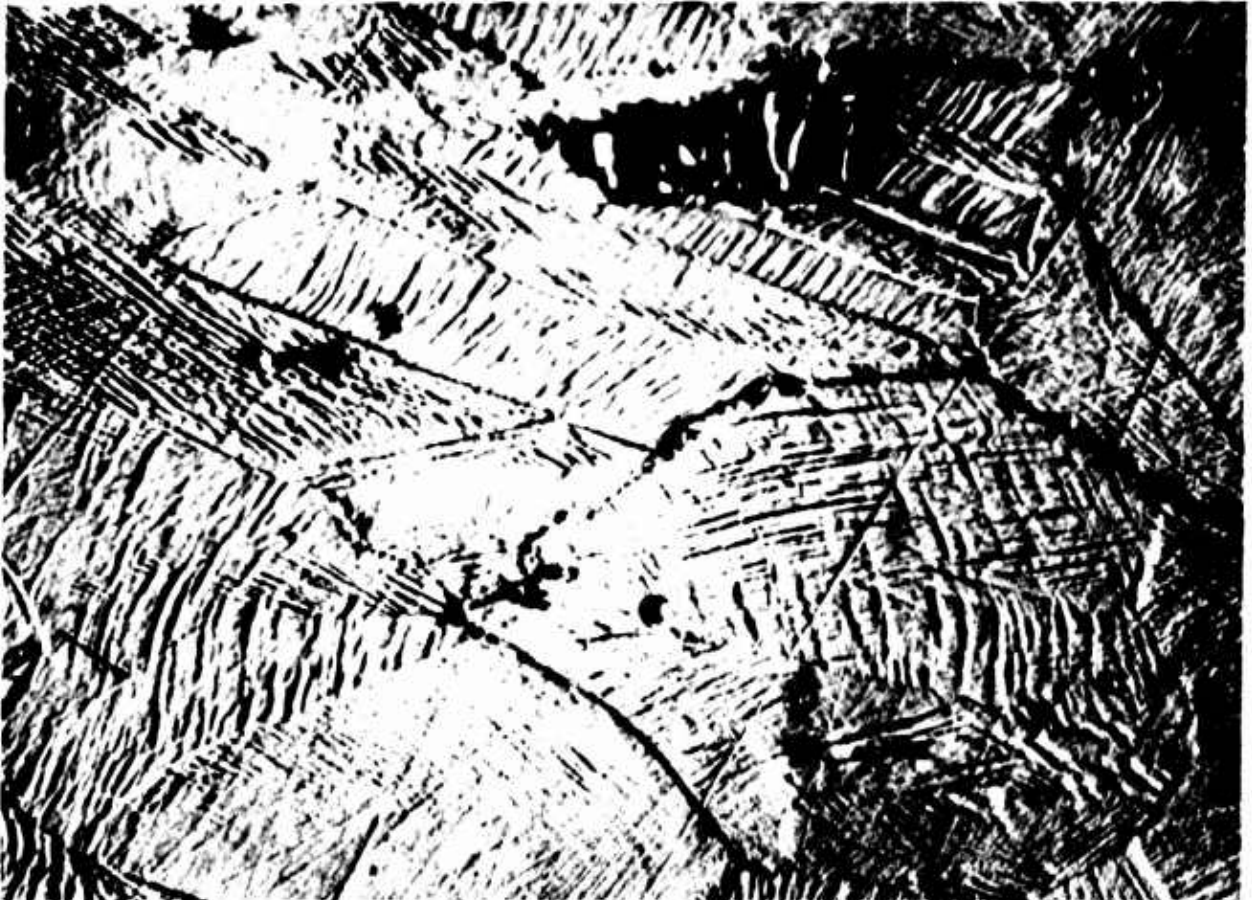
Material	<u>Hastelloy C</u>	Neg.No.	<u>W76</u>
Specimen	<u>LU 354</u>	Neg.Mag.	<u>1,000X</u>
Etchant	<u>HCl+H<sub>2</sub>O<sub>2</sub></u>	Photo Enlargement	<u>None</u>

The microstructure shows the severely deformed, Ni-rich, austenitic matrix and the strain orientation direction within each grain and on the annealing twins. Note that the large carbide has ruptured perpendicular to the load direction.

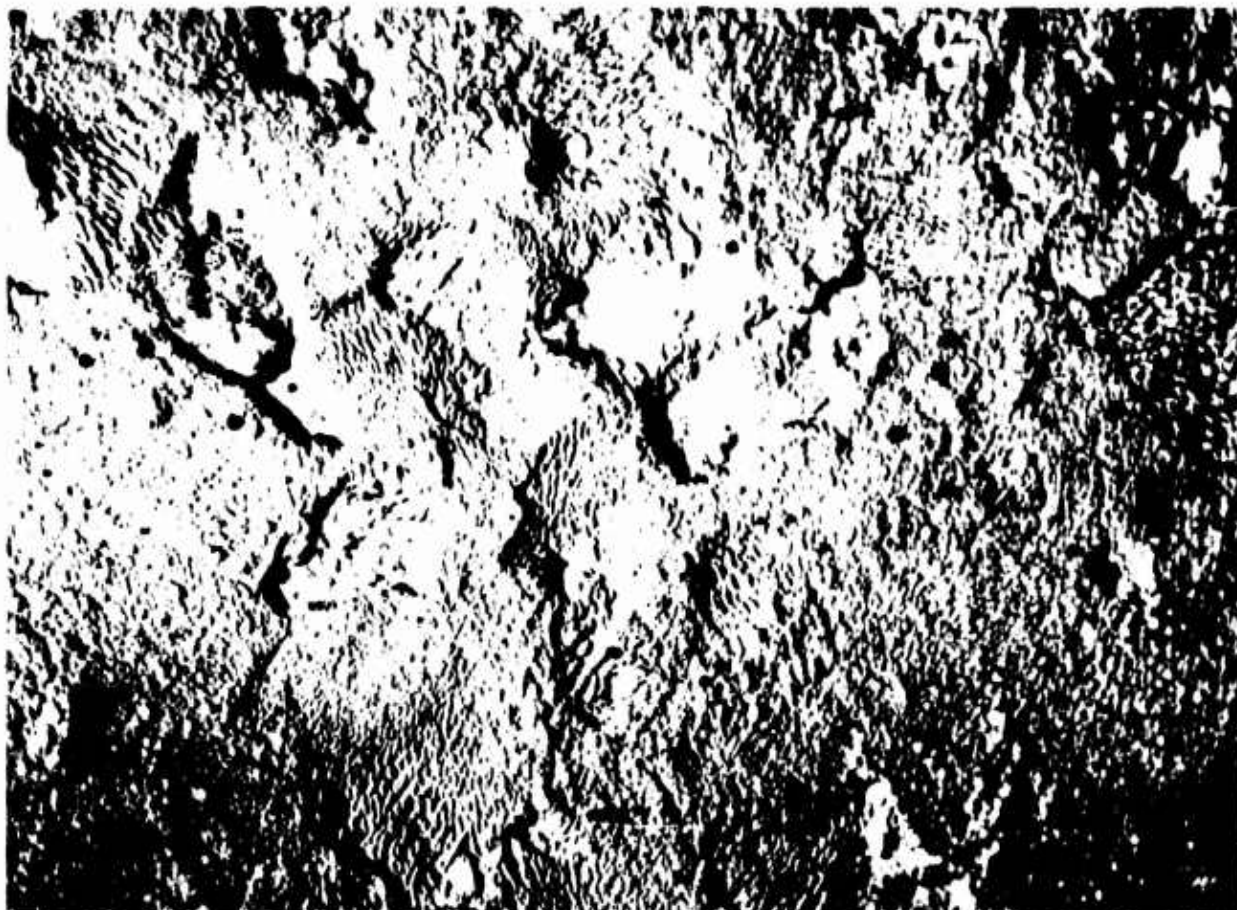
Material Titanium A-110-AT Neg.No. W32  
Specimen TU 285 Neg.Mag. 1,000X  
Etchant Kroll's Reagent, then HG-NYU Photo Enlargement None

The microstructure shows the typical alpha-Ti matrix. Note the alpha-grain orientation as depicted by the etchant attack.

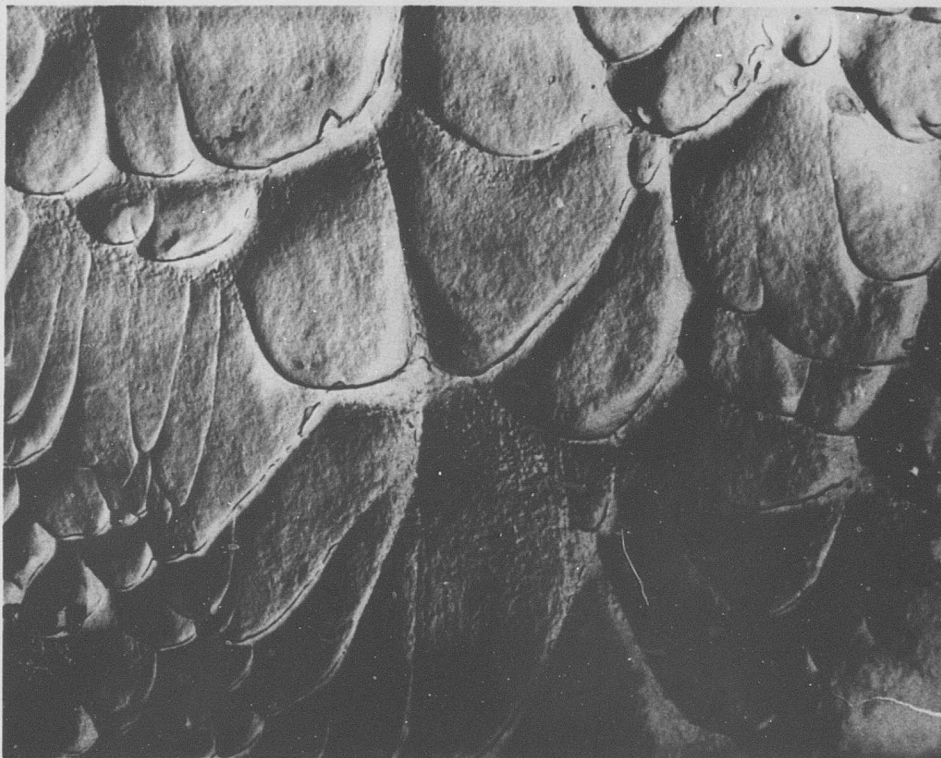
Material	Titanium A-110-AT	Neg.No.	91-11
Specimen	TU 285	Neg.Mag.	2,100X
Etchant	None	Photo Enlargement	2X

The fracture at the edge consists of low-angle shear microvoids (dimples).

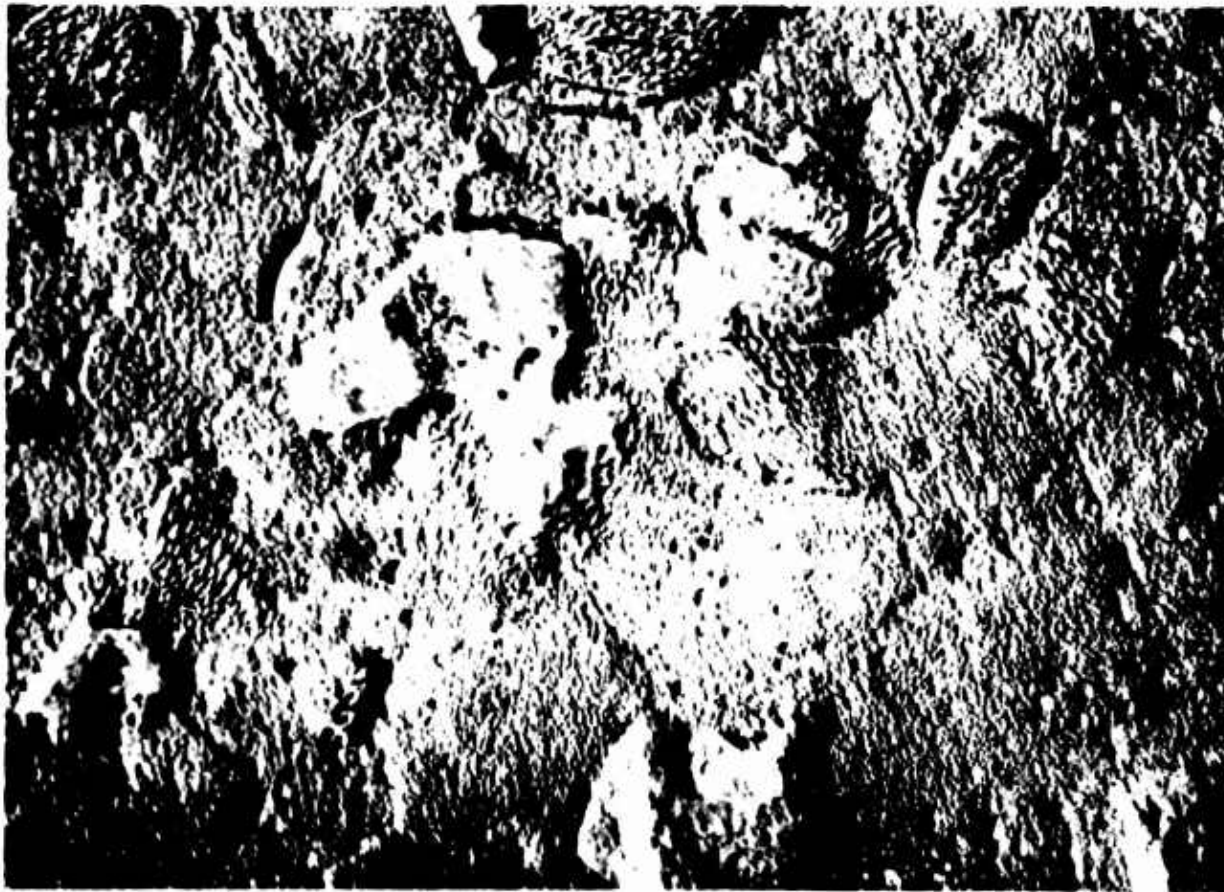
Material Titanium A-110-AT Neg.No. W33  
Specimen TWU 298 Neg.Mag. 1,000X  
Etchant Kroll's Reagent, then HG-NYU Photo Enlargement None

The microstructure shows the typical alpha-Ti matrix. Note the alpha-Ti grain orientation as depicted by the etchant.
